Slip 4 Additional Data Collection

Duwamish Sediment Other Area and Southwest Bank

Corrective Measure and Habitat Project

Boeing Plant 2, Seattle/Tukwila, Washington

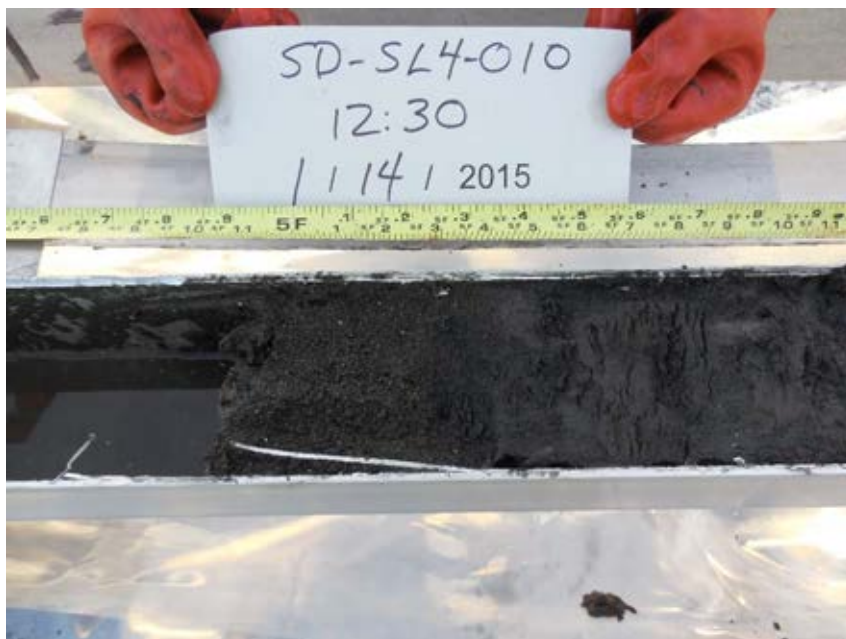
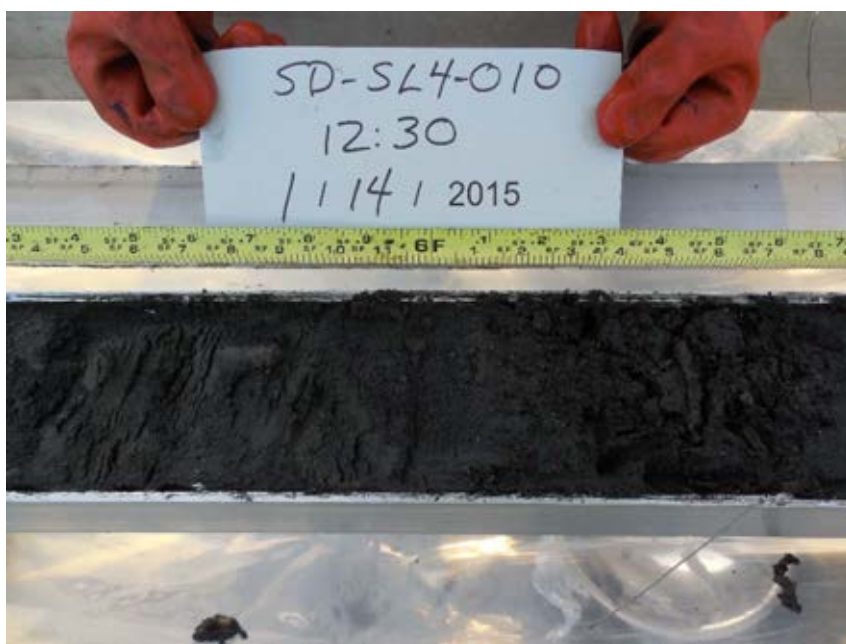
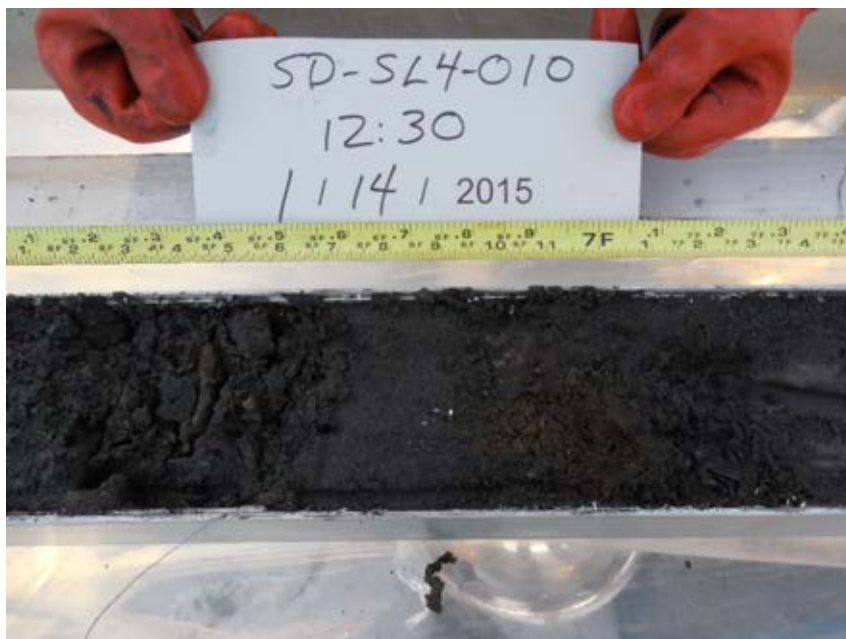
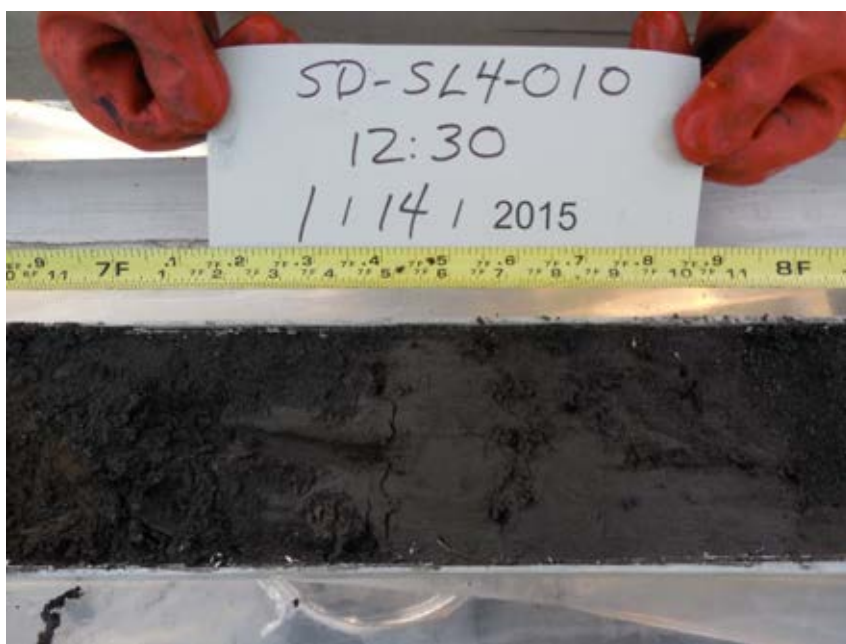
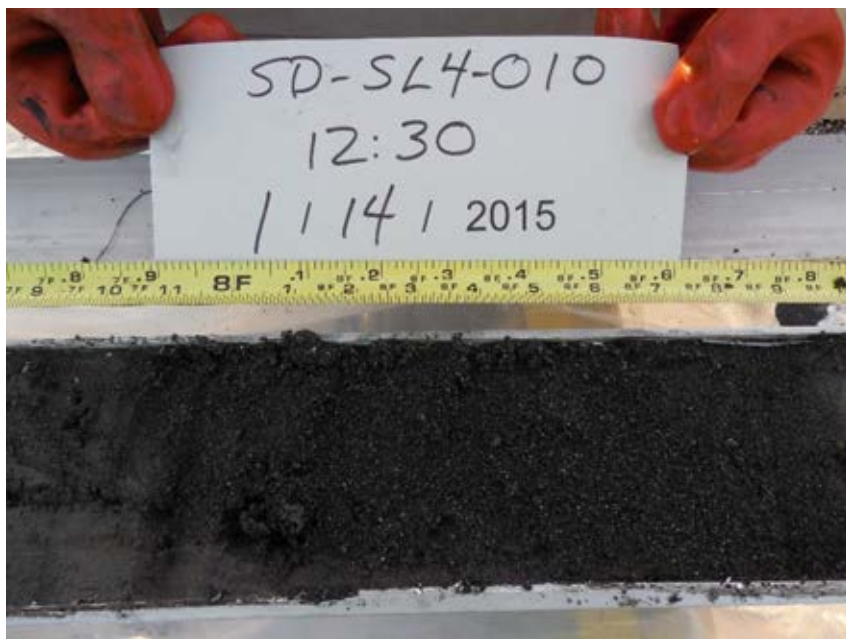
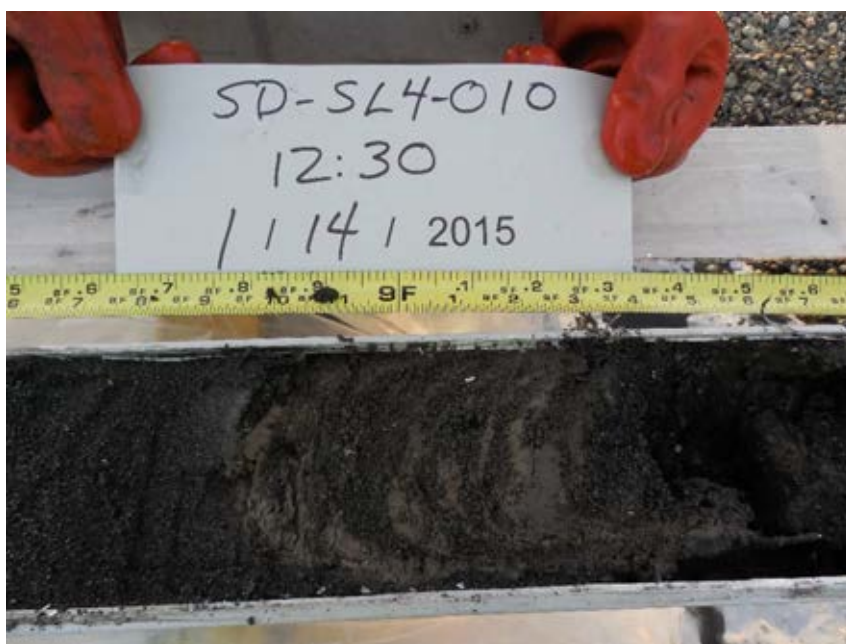
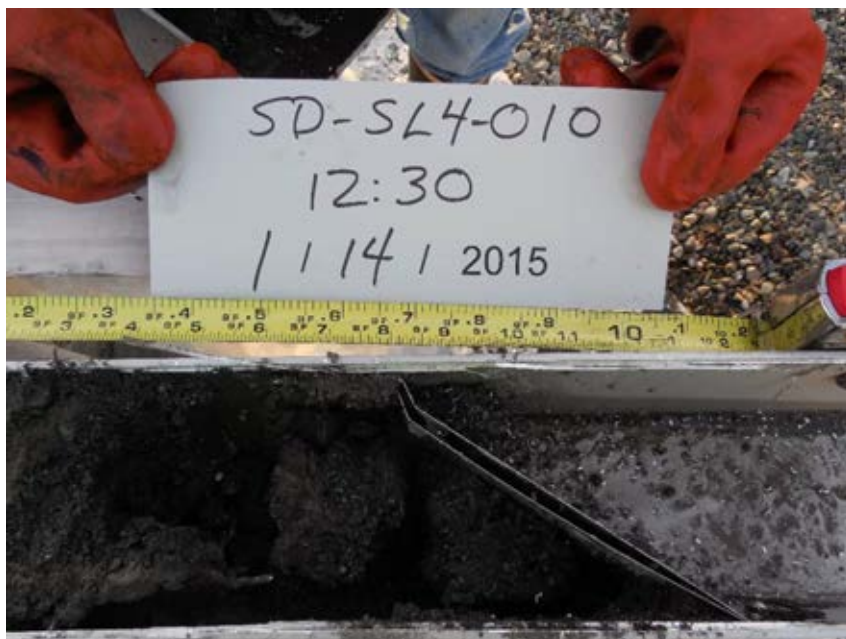
Station SD-SL4-010

Depth below mudline (ft.)	Visual Description of Sediment	Summary Interpretation	Sample ID No.
0.0	Moist gray fine to medium SAND		SD-SL-010-0000
1.0	Moist firm sand with silt		SD-SL-010-0010
2.0	Medium gray sand matrix with wood debris (limb pieces and large chunks)		SD-SL-010-0020
3.0	Moist dark gray fine SAND with a trace of wood debris		SD-SL-010-0030
4.0	Moist medium gray SILT with a trace of sand		SD-SL-010-0040
5.0	Dry, loose medium to fine dark gray SAND		SD-SL-010-0050
6.0	Interbedded layers of fine to medium SAND and amedium gray silt layers		SD-SL-010-0060
7.0	End of sediment		
8.0	End of Core	End of Core	End of Core
9.0

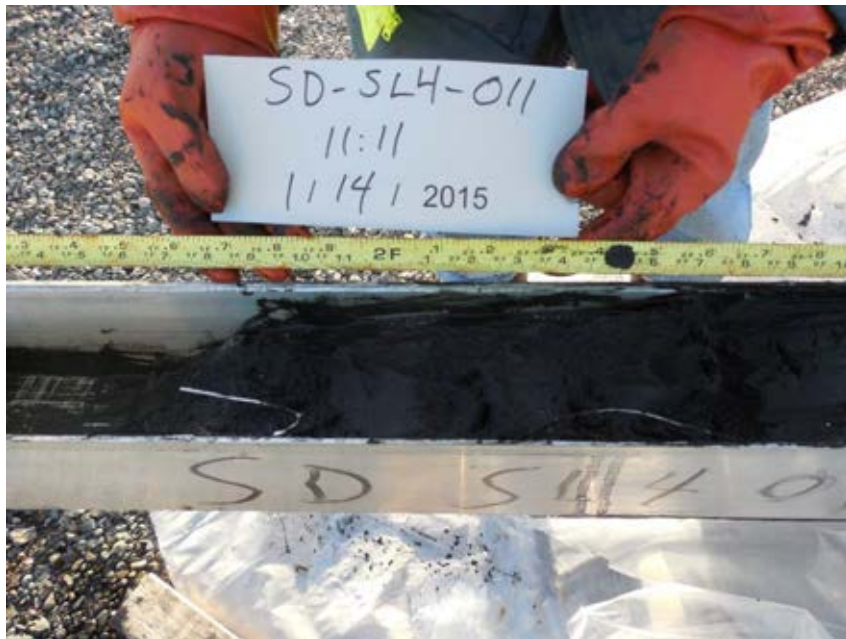
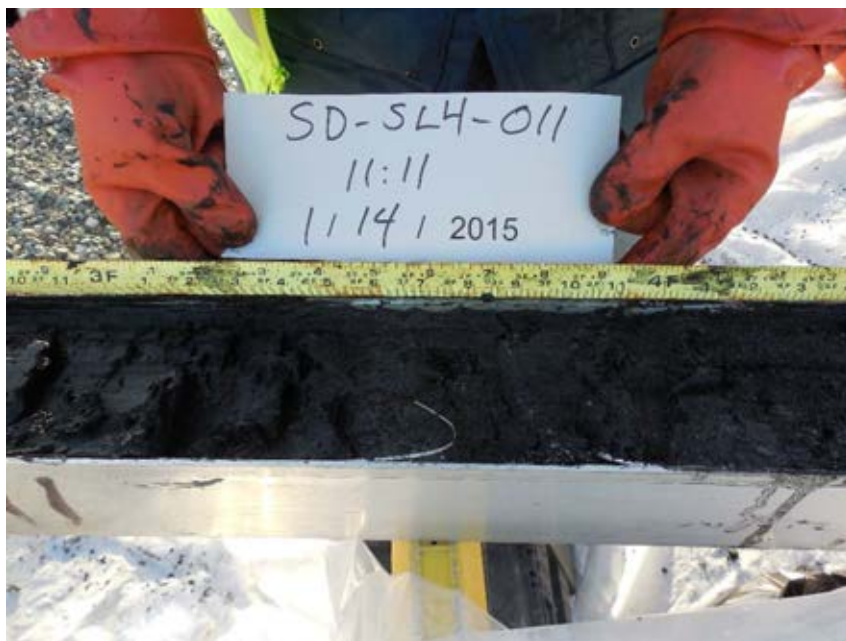
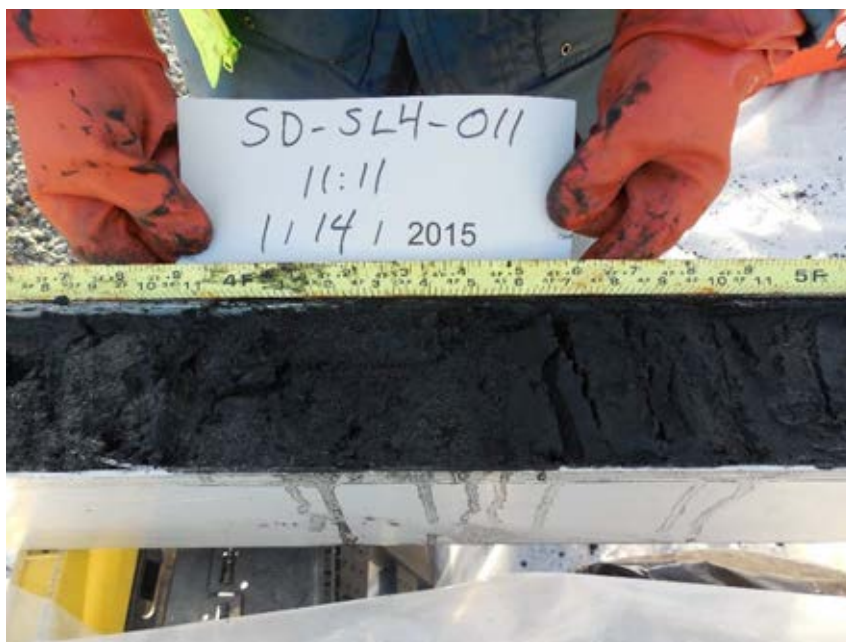
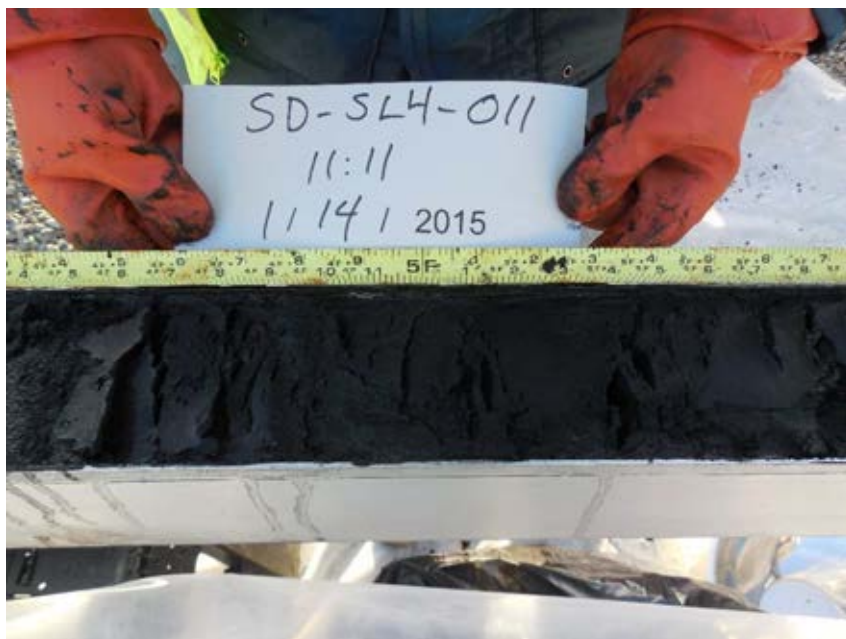
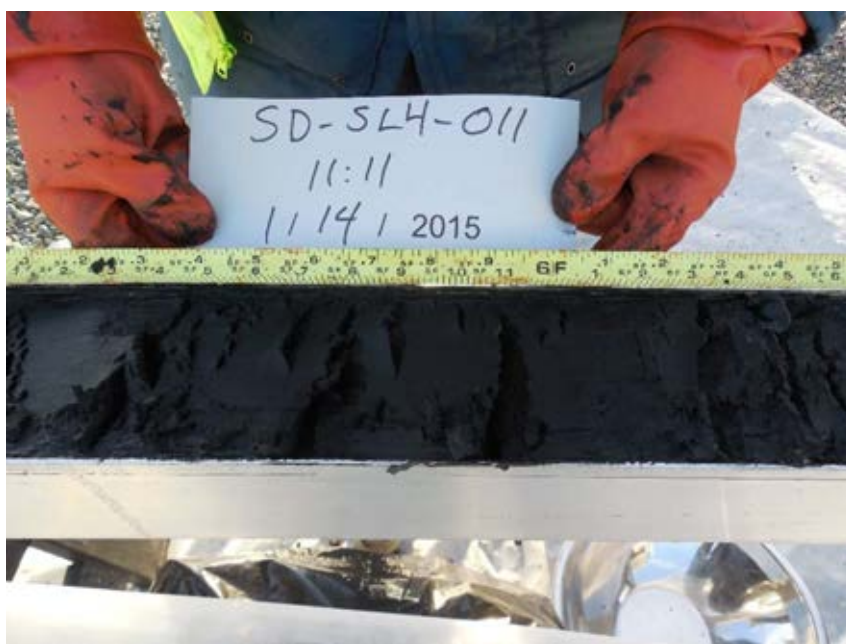
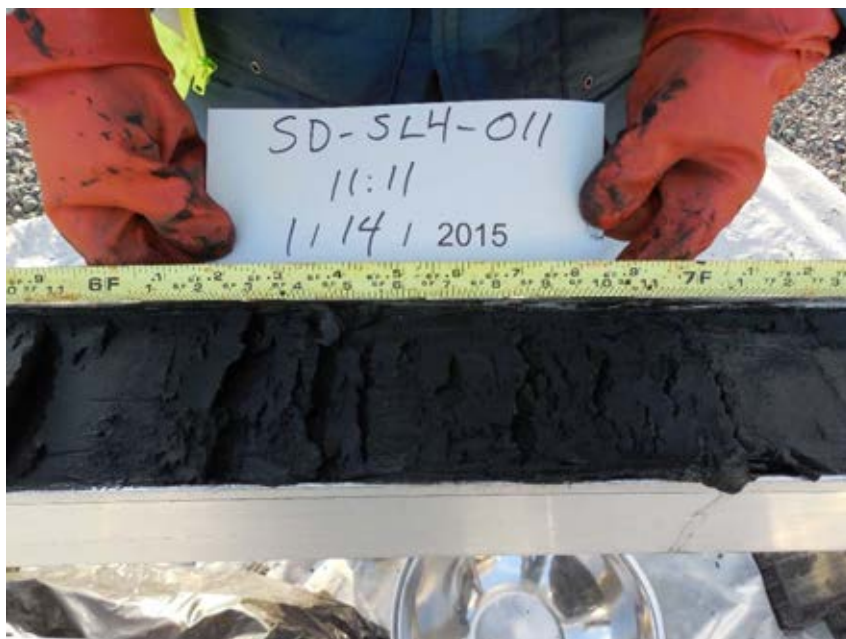
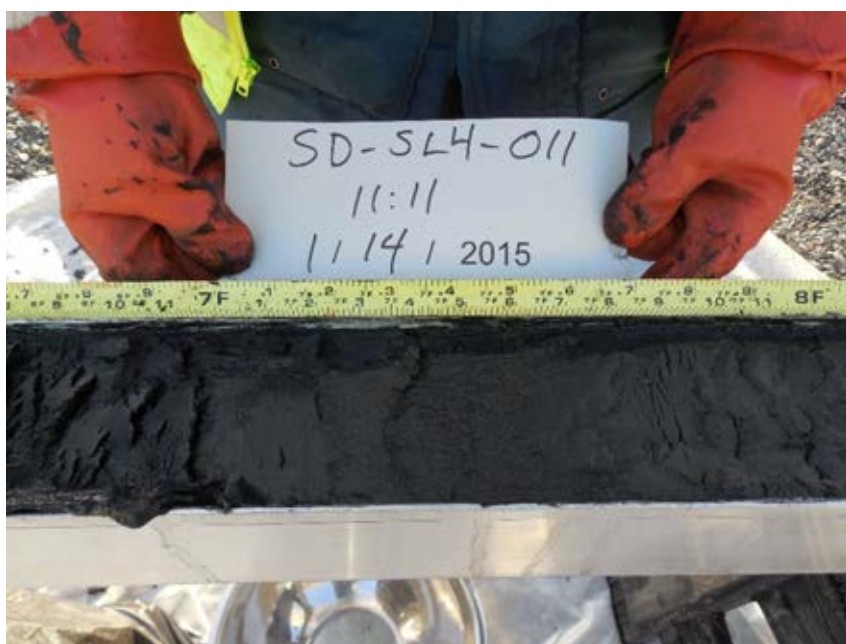
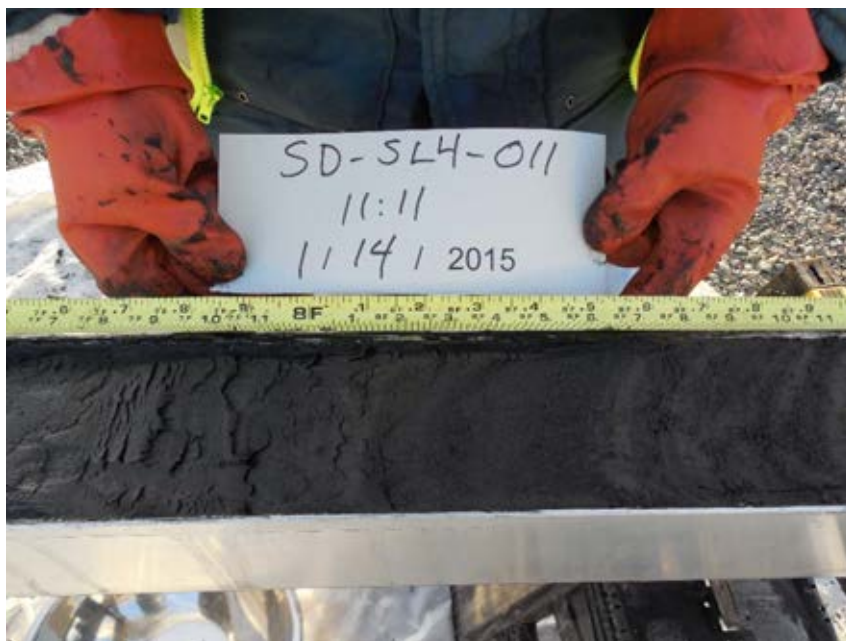
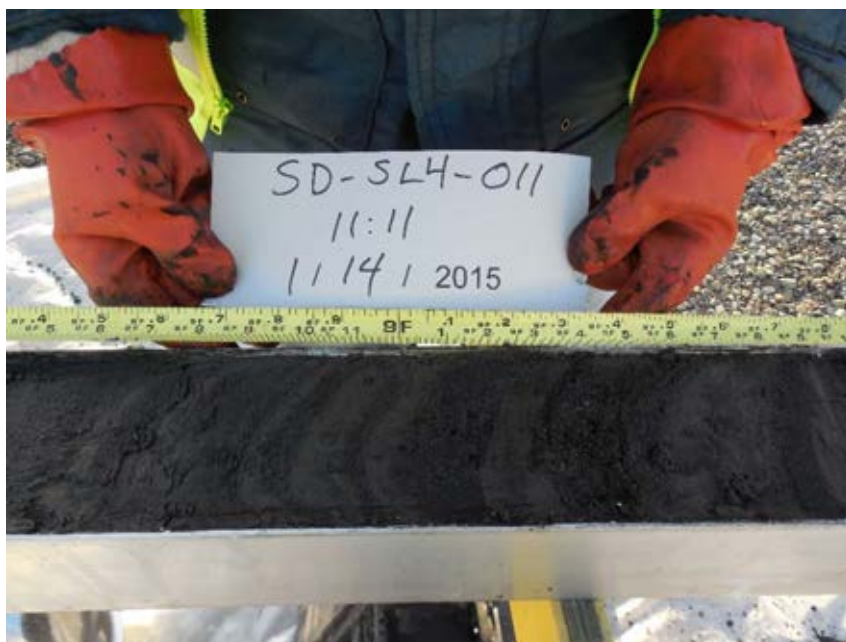
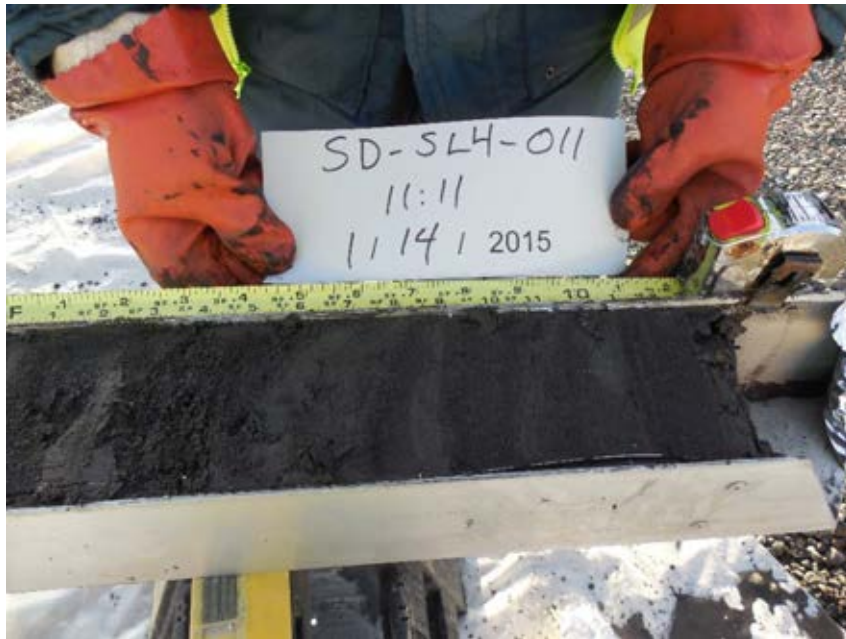
Station SD-SL4-011

Depth below mudline (ft.)	Visual Description of Sediment	Summary Interpretation	Sample ID No.
0.0			SD-SL-011-0000
1.0	Wet dark gray to black slightly sandy SILT, very loose		SD-SL-011-0010
2.0			SD-SL-011-0020
3.0	Wet becoming drier with depth dark gray to black silty SAND with scattered gravel (rounded) scattered chunks of wood		SD-SL-011-0030
4.0			SD-SL-011-0040
5.0	Moist dark gray to black slightly sandy SILT with scattered lenses of dark gray fine sand		SD-SL-011-0050
6.0			SD-SL-011-0060
7.0			SD-SL-011-0070
8.0	Moist becoming dry medium gray sandy SILT interbedded with fine sand. Sandy interbedding becoming wider with depth.		SD-SL-011-0080
9.0			SD-SL-011-0090
10.0	End of Core	End of Core	End of Core
